**US Army Corps
of Engineers®**
Engineer Research and
Development Center

South Jetty Sediment Processes Study, Grays Harbor Washington: Evaluation of Engineering Structures and Maintenance Measures

April 2003

Final report

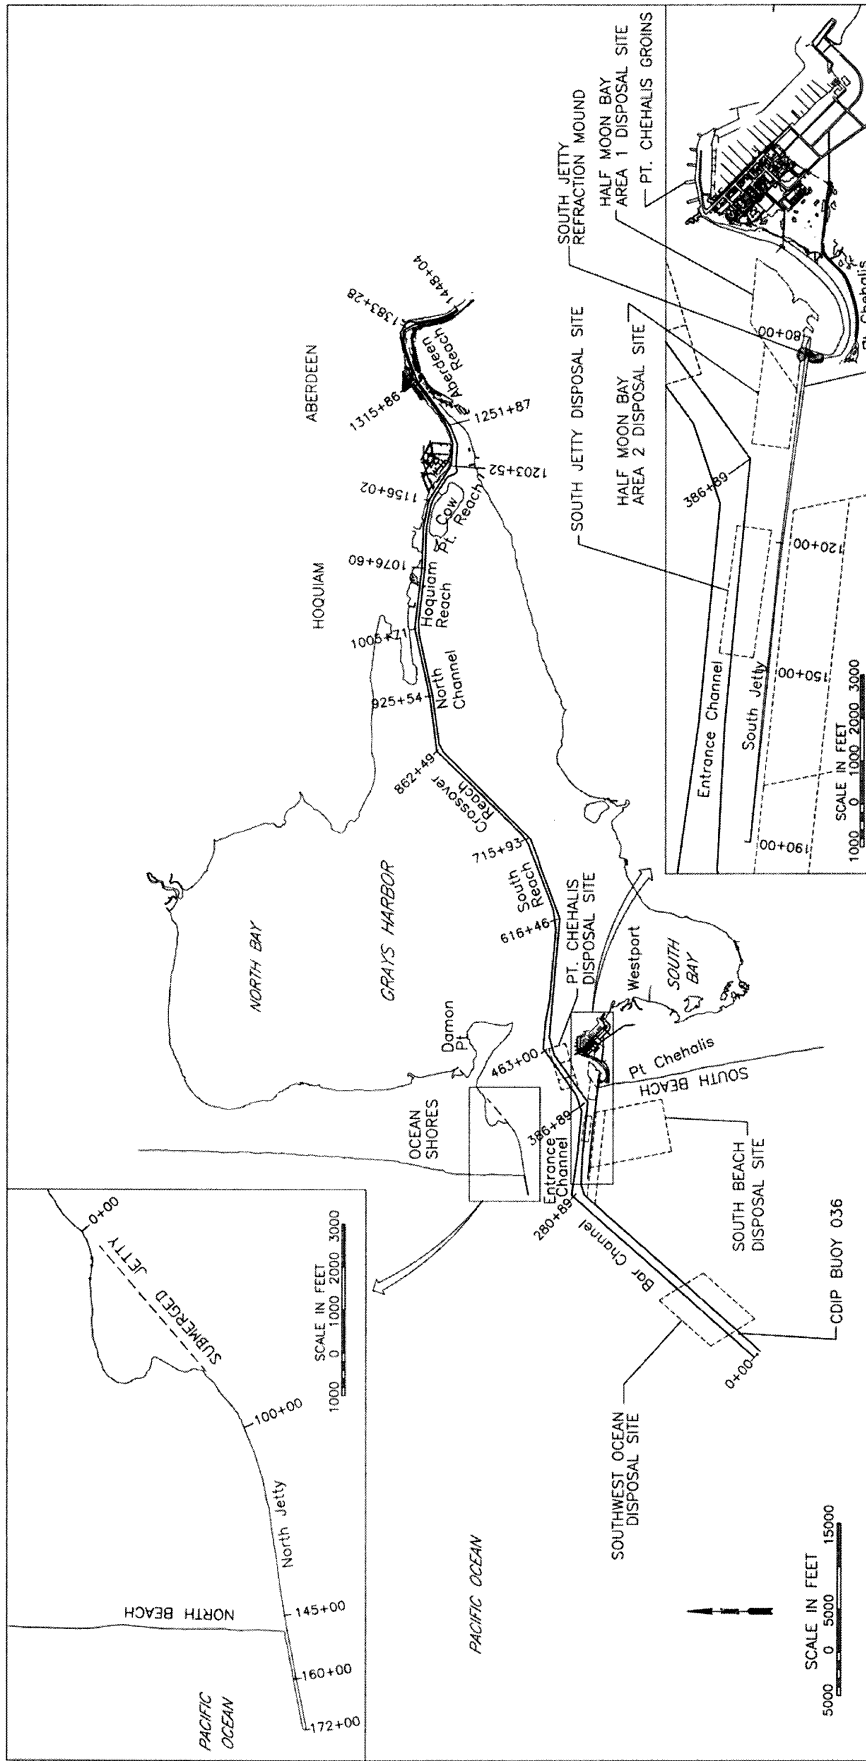
Figure 1. Grays Harbor navigation project

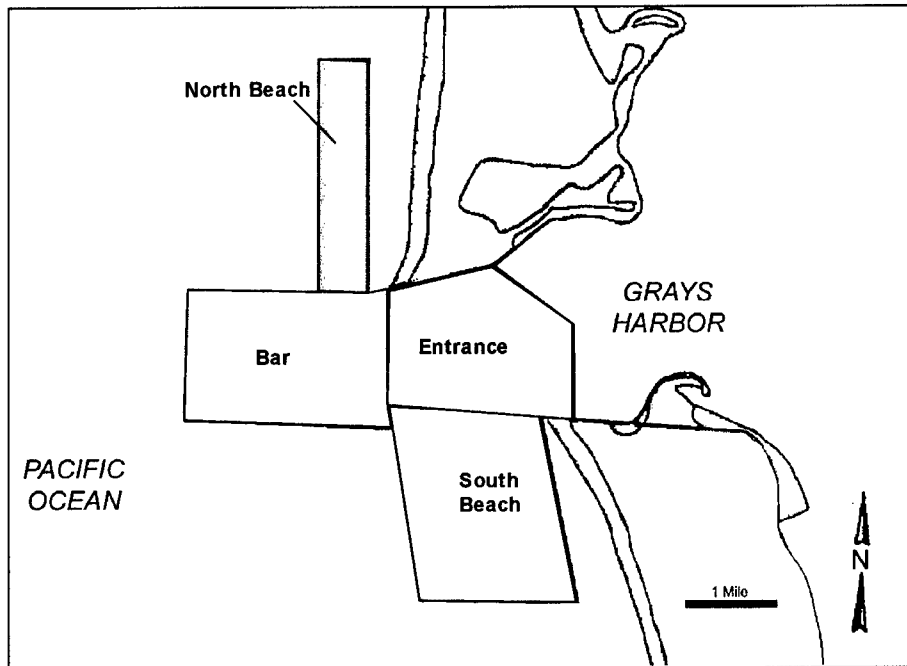
Figure 2. Areas for sediment volume calculations

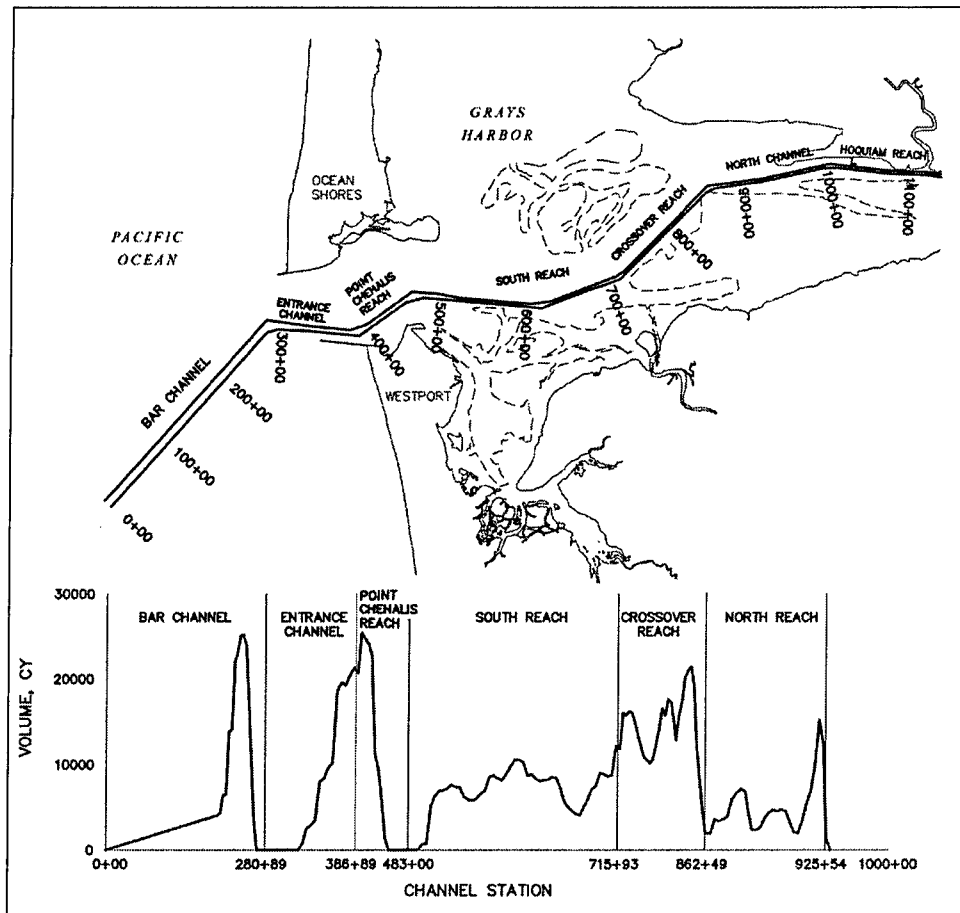
Figure 4. Calculated distribution of dredging volumes, 1991 to present

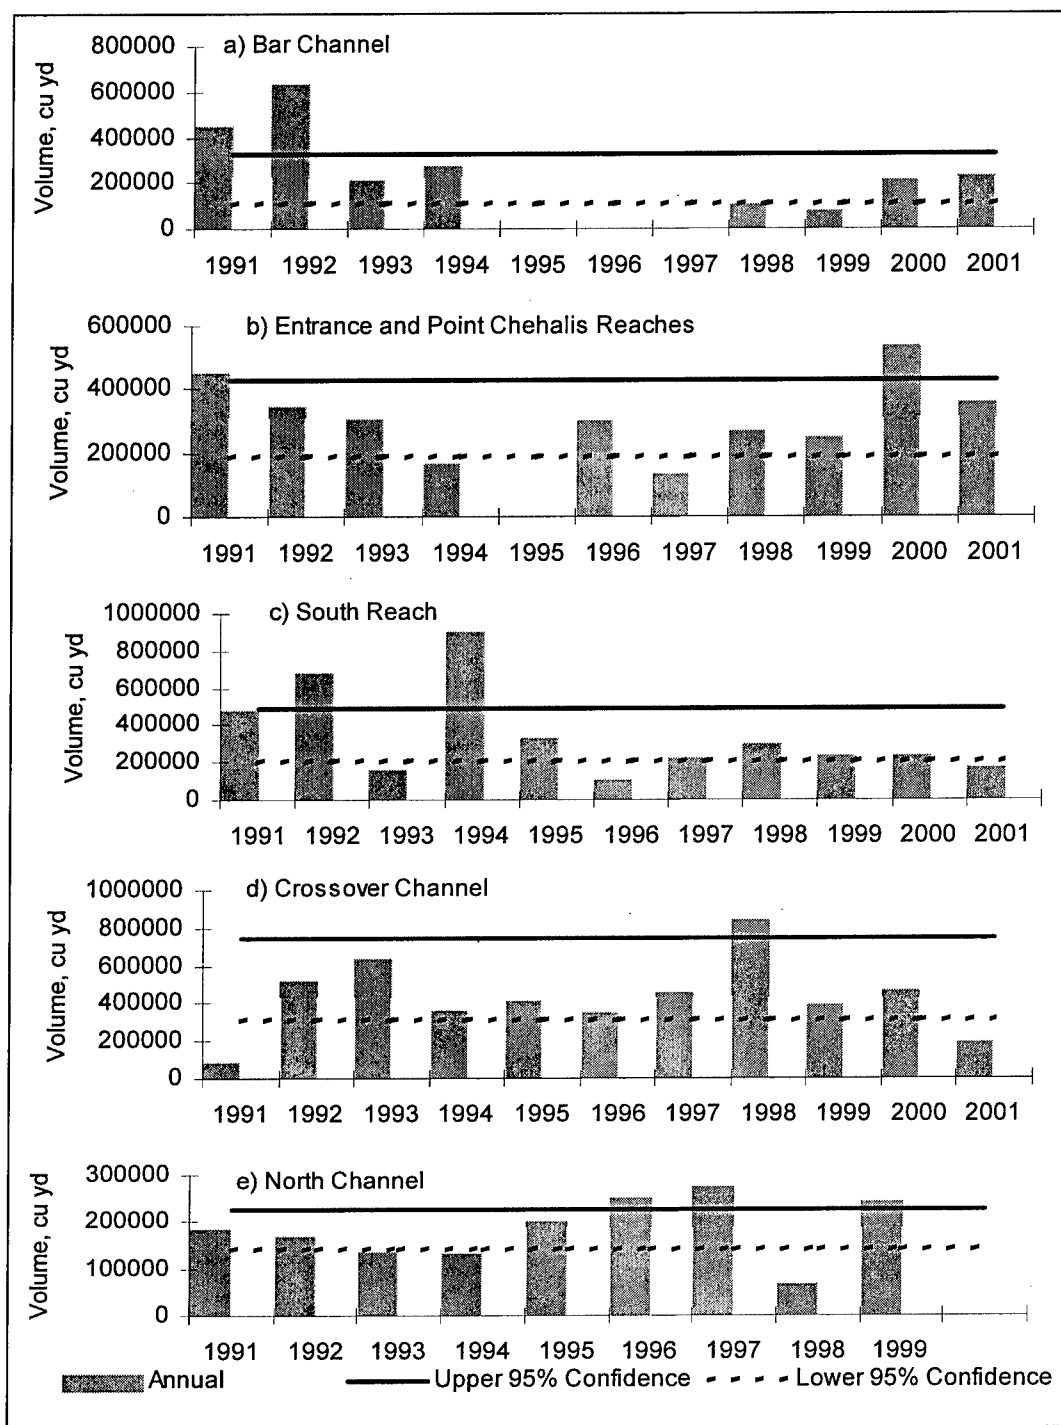
Figure 5. Annual maintenance dredging volumes between 1991 and 2001

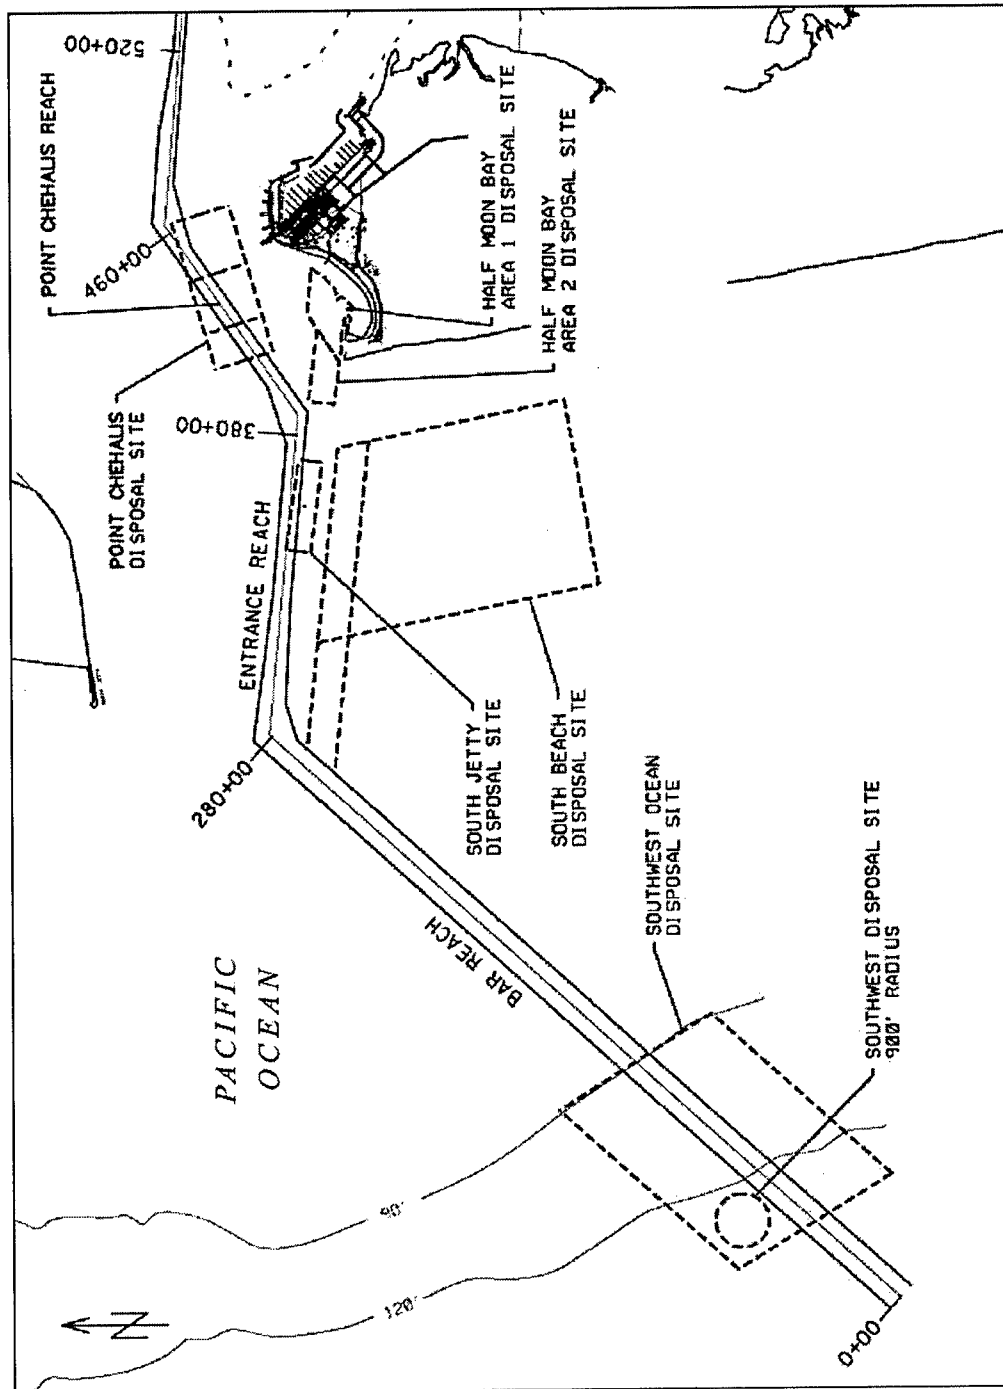
Figure 6. Location of dredged material disposal areas in and near Grays Harbor entrance

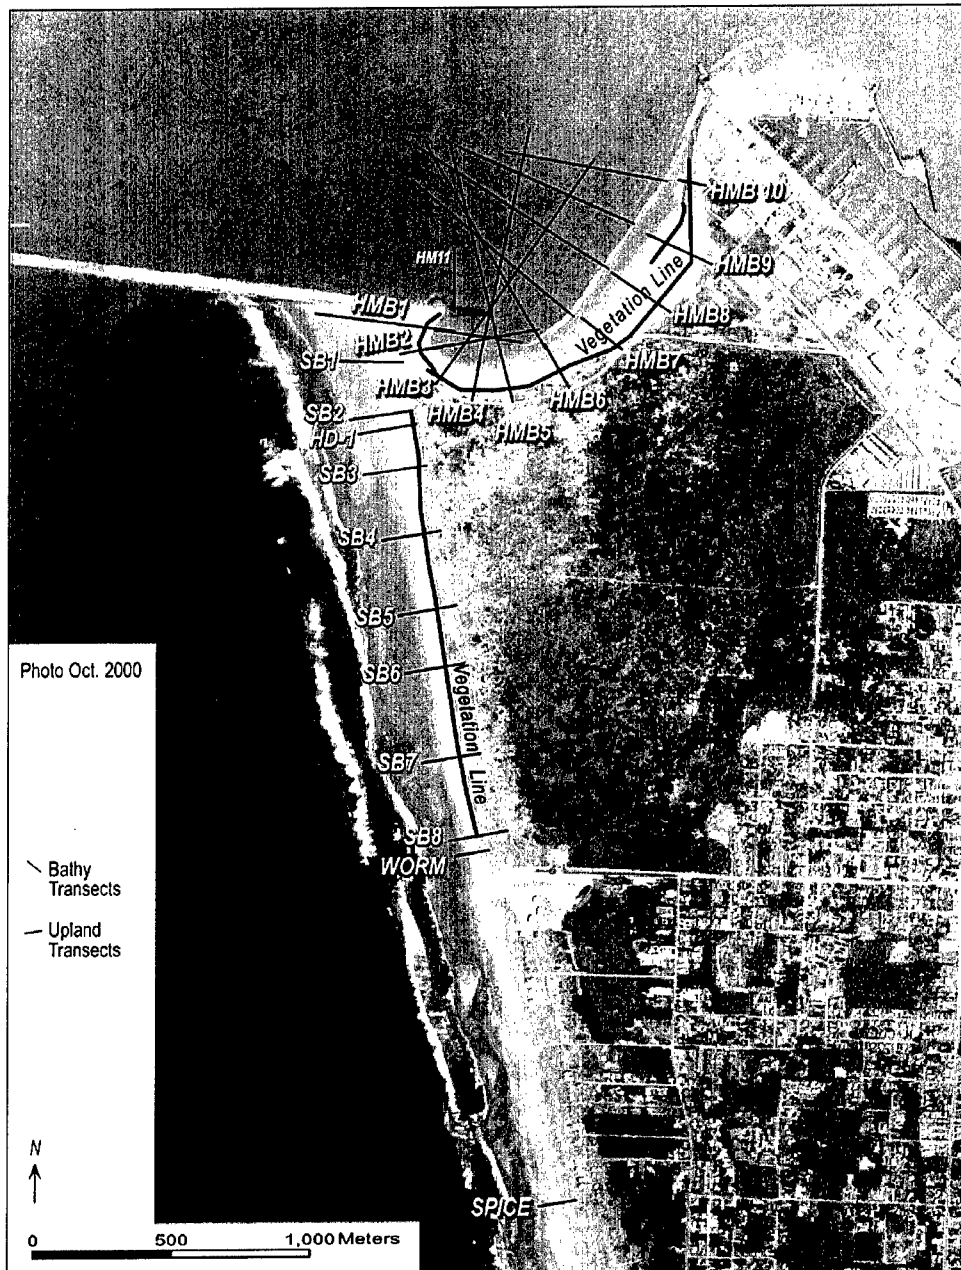
Figure 7. South Beach/Half Moon Bay survey transect locations

Figure 7 shows the location of the survey transects. Transects HD-1, Worm, and Spice were established as part of the southwest Washington coastal erosion study by the WDOE, and cross-shore profile data have been collected since 1997 (Ruggiero and Voigt 2000). Transects HMB1 to HMB10 and SB1 to SB8 were established in December 2001 following the series of storms that led to damage of the breach fill, revetment fill, and shoreline erosion. The WDOE was

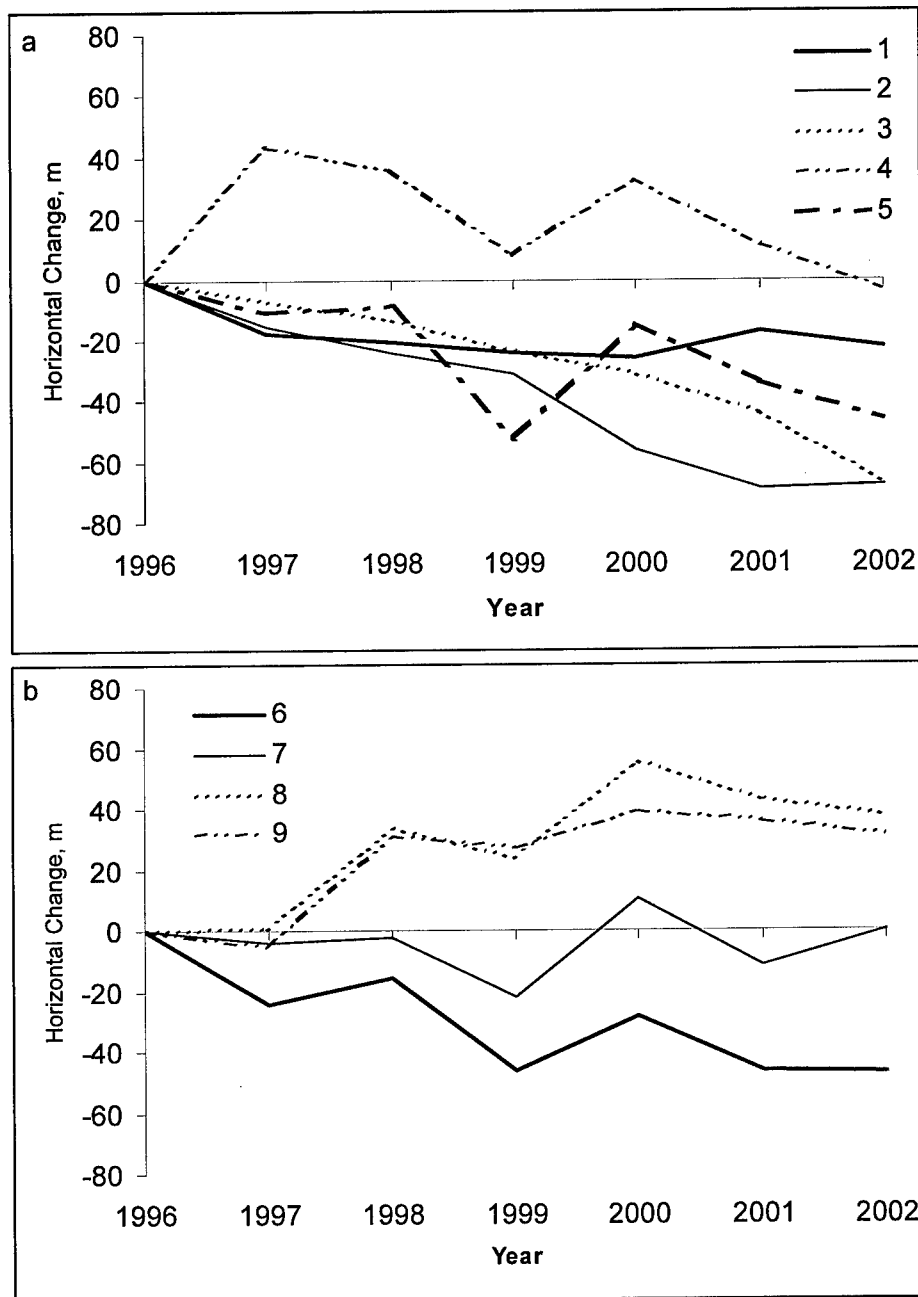
Figure 9. Half Moon Bay shoreline position change relative to 1996 position at (a) Transects HMB1 to HMB5, and (b) Transects HMB6 to HMB9

Figure 9 shows the change in shoreline position (AHWL) at Half Moon Bay Transects (HMB1 to HMB9) relative to the 1996 shoreline position. The shoreline positions document the extent of adjustment of the shoreline to the local sediment transport. The time series show that net shoreline recession has occurred at Transects HMB1, HMB2, HMB3, HMB5 and HMB6; no significant net change has occurred at Transects HMB4 and HMB7; and net advance has occurred at Transects HMB8 and HMB9. Overall, the shoreline position data between 1996 and 2002 reveal a pattern of net shoreline recession of between 2.5 to 12 m/year at the western end of Half Moon Bay west of Transect HMB7 and shoreline advance of approximately 7 m/year east of Transect HMB7.

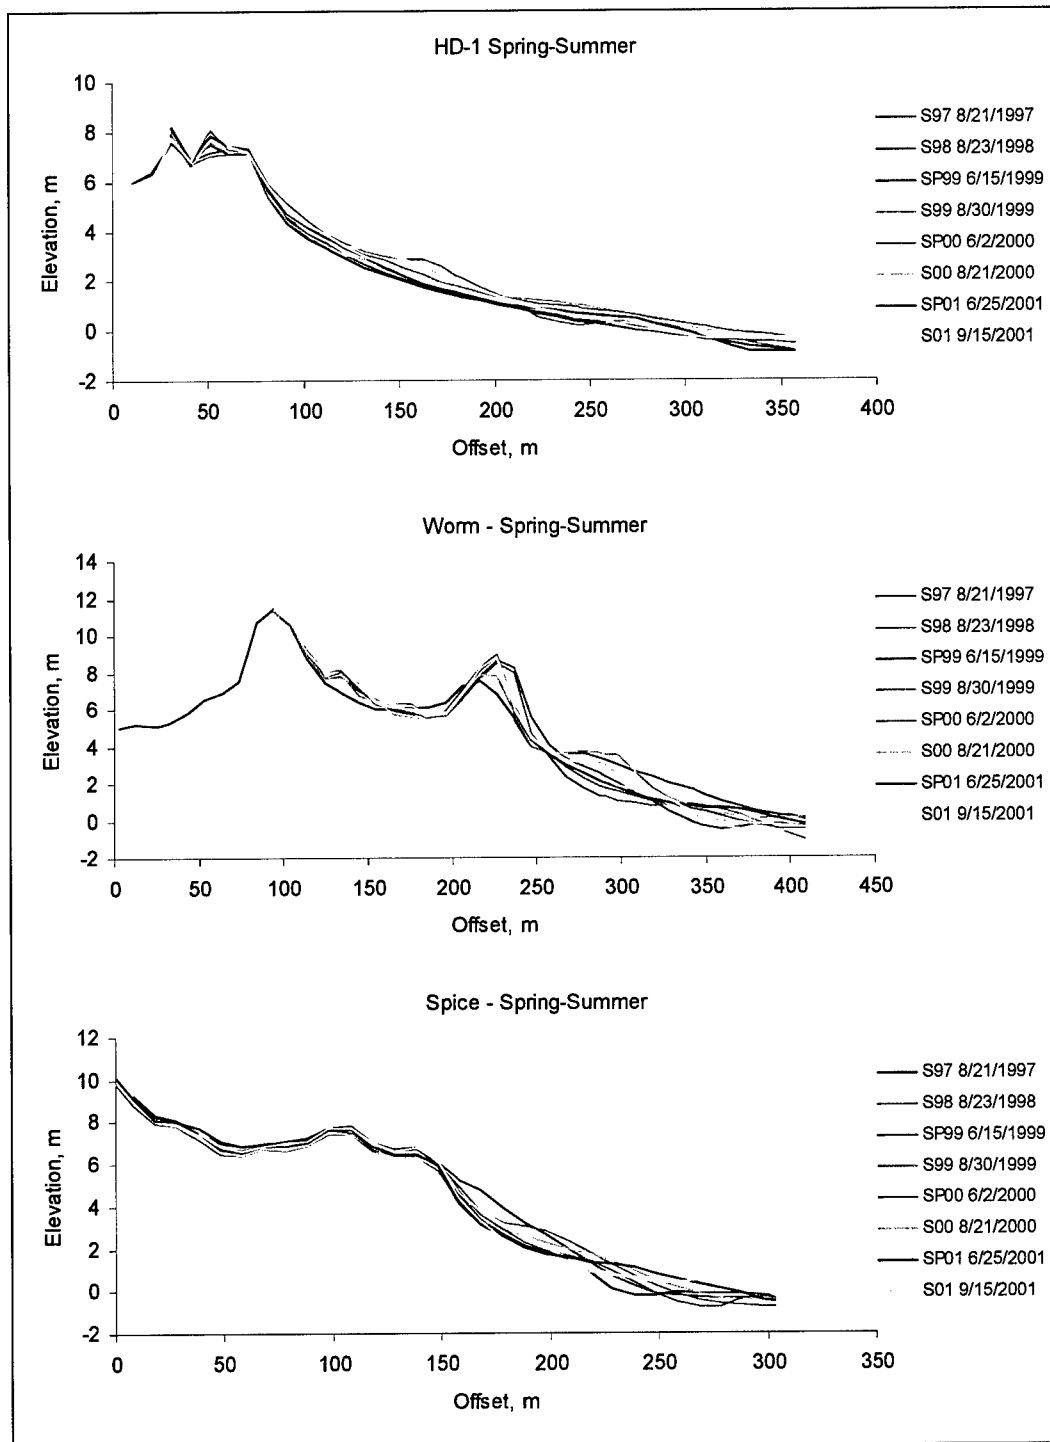
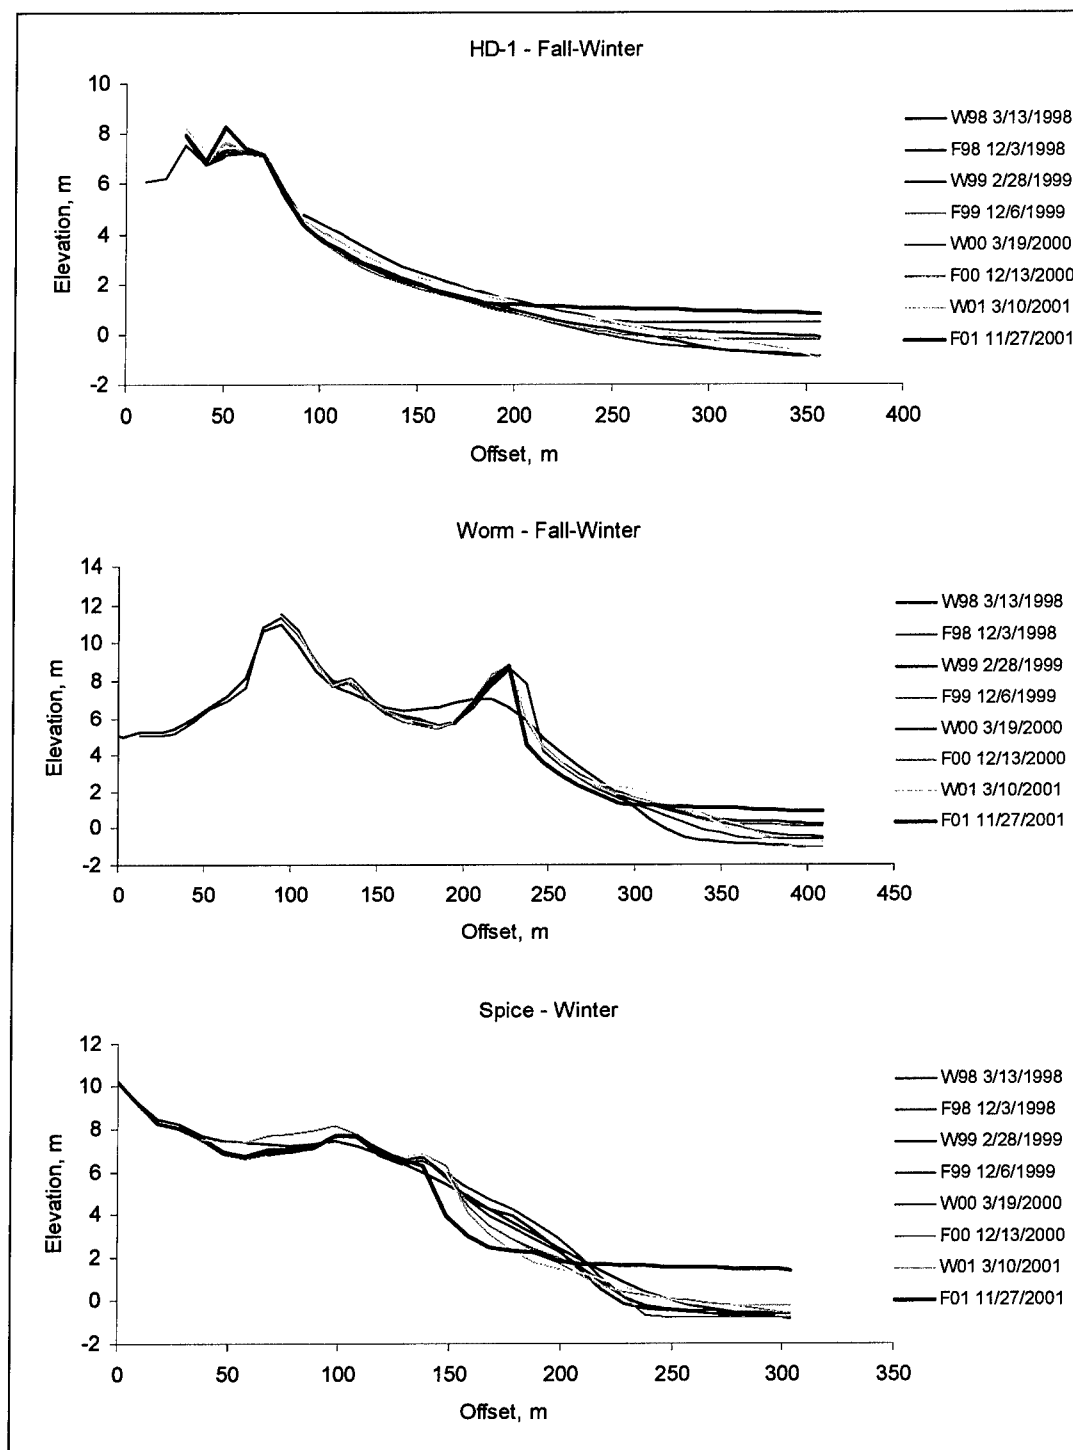
Figure 10. South Beach profiles (Continued)

South Beach profiles. South Beach transects HD-1, Worm, and Spice were surveyed biannually starting in summer 1997 and quarterly since fall 1998. Transects SB1-8 were surveyed for the first time by the WDOE in December 2001. Figure 10 shows the rectified profiles at the HD-1, Worm, and Spice transects. Transects have been separated into winter and summer profiles. These profiles exhibit significant intra-annual variability seaward of the foredune, with erosion of the shore in winter months and accretion in summer.

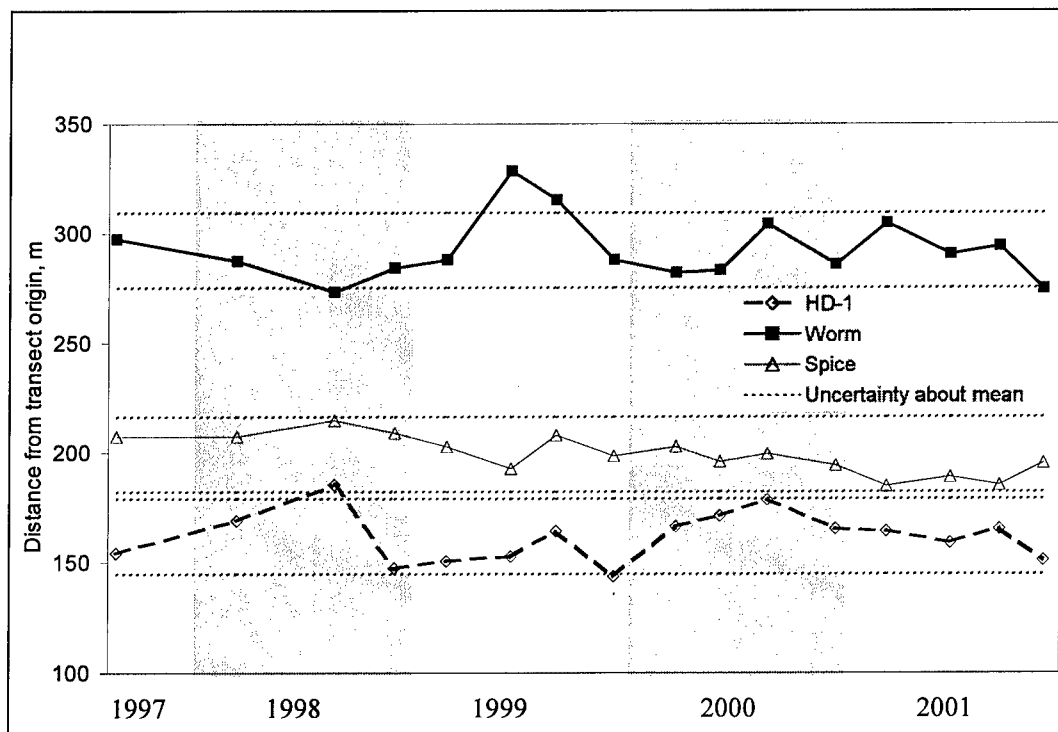
Figure 11. Temporal variation in horizontal position of 2-m contour

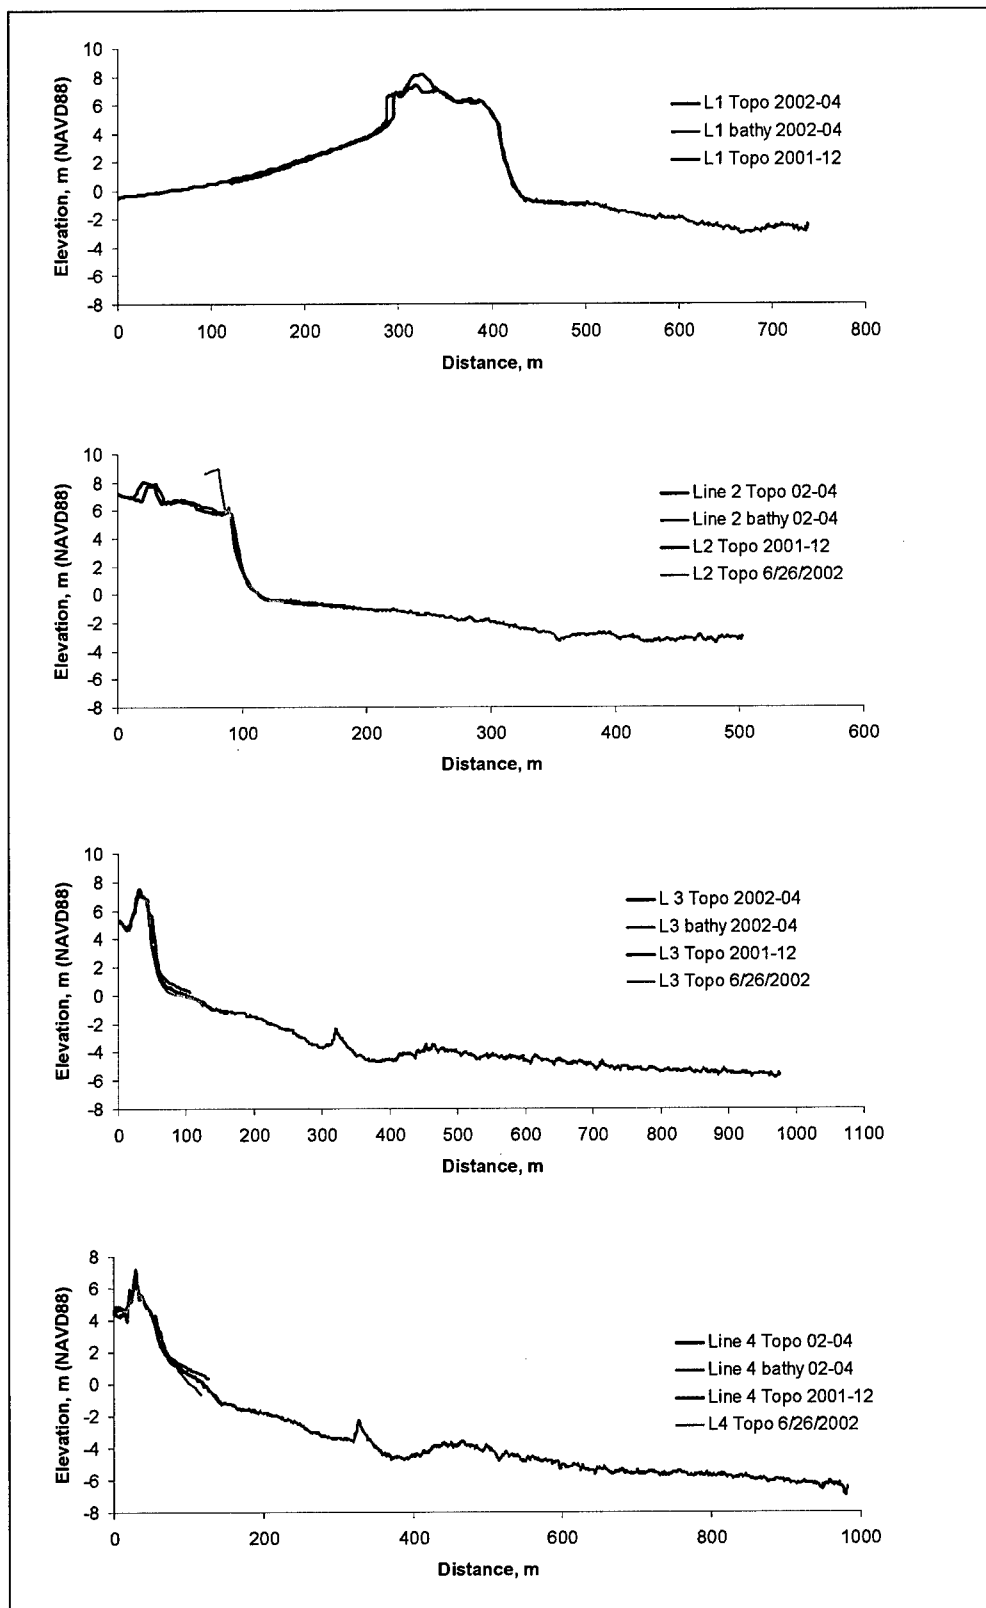
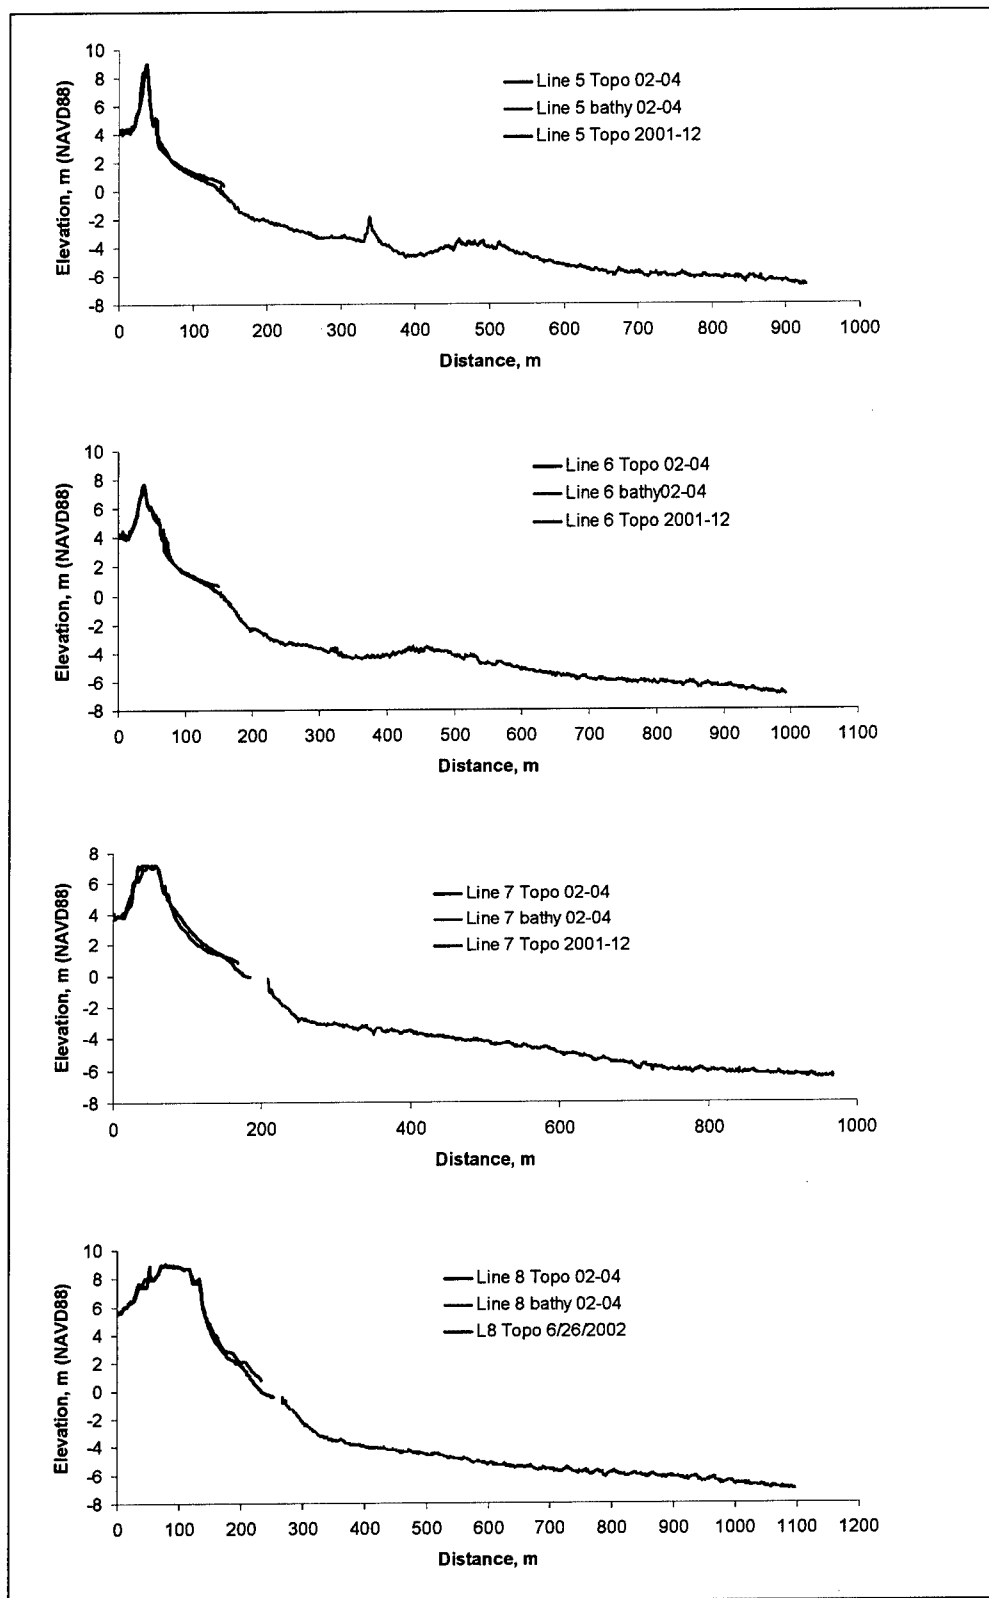
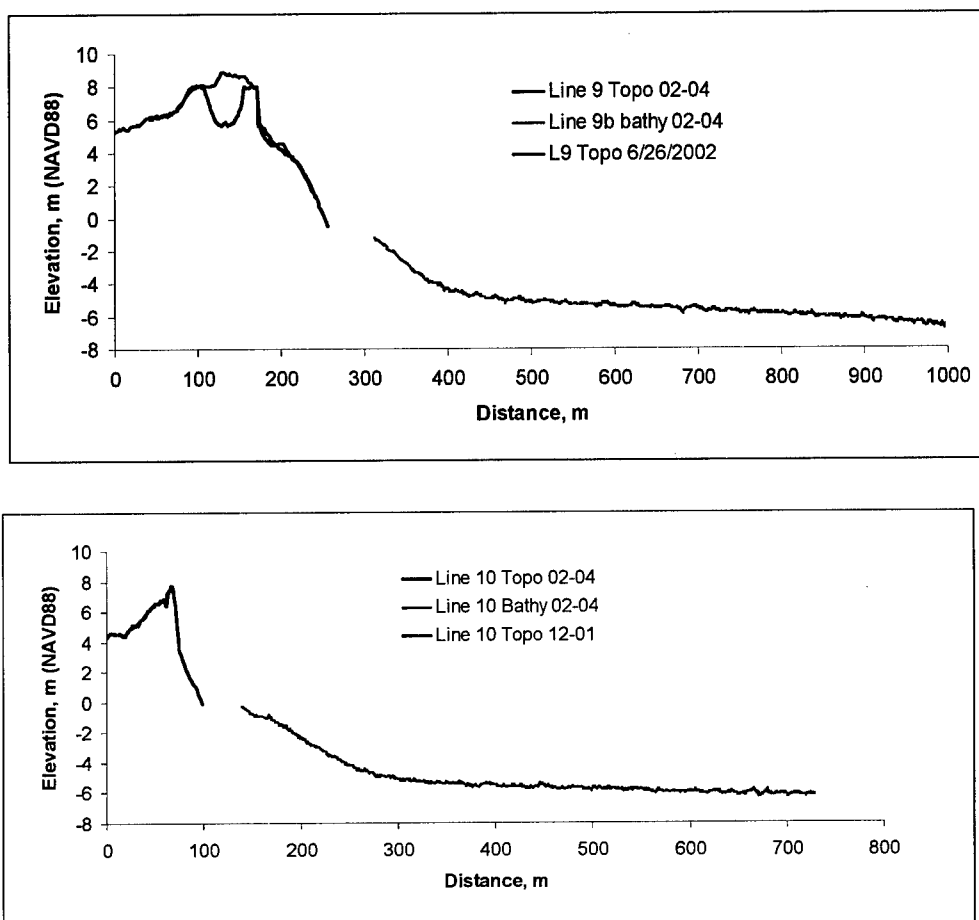
Figure 12. Half Moon Bay profiles (Sheet 1 of 3)

Figure 21 shows profiles at Transects HMB7 to HMB9 in December 2001 and April 2002 in the revetment fill section of the beach. Figure 12 shows the complete profile including bathymetry. All of the profiles have a steep scarp between elevations of +4 and +8 m, NAVD88. At the eastern end (Transect HMB9), the beach has a steep (1V:13H) slightly convex upwards foreshore that transitions to a broad gently sloping shelf (1V:240H) at approximately elevation -4 m, NAVD88 and extends at least 600 m seaward. To the south and west, the profiles at HMB8 and HMB9 become progressively more smoothly varying and concave upwards, and the scarp is less developed.

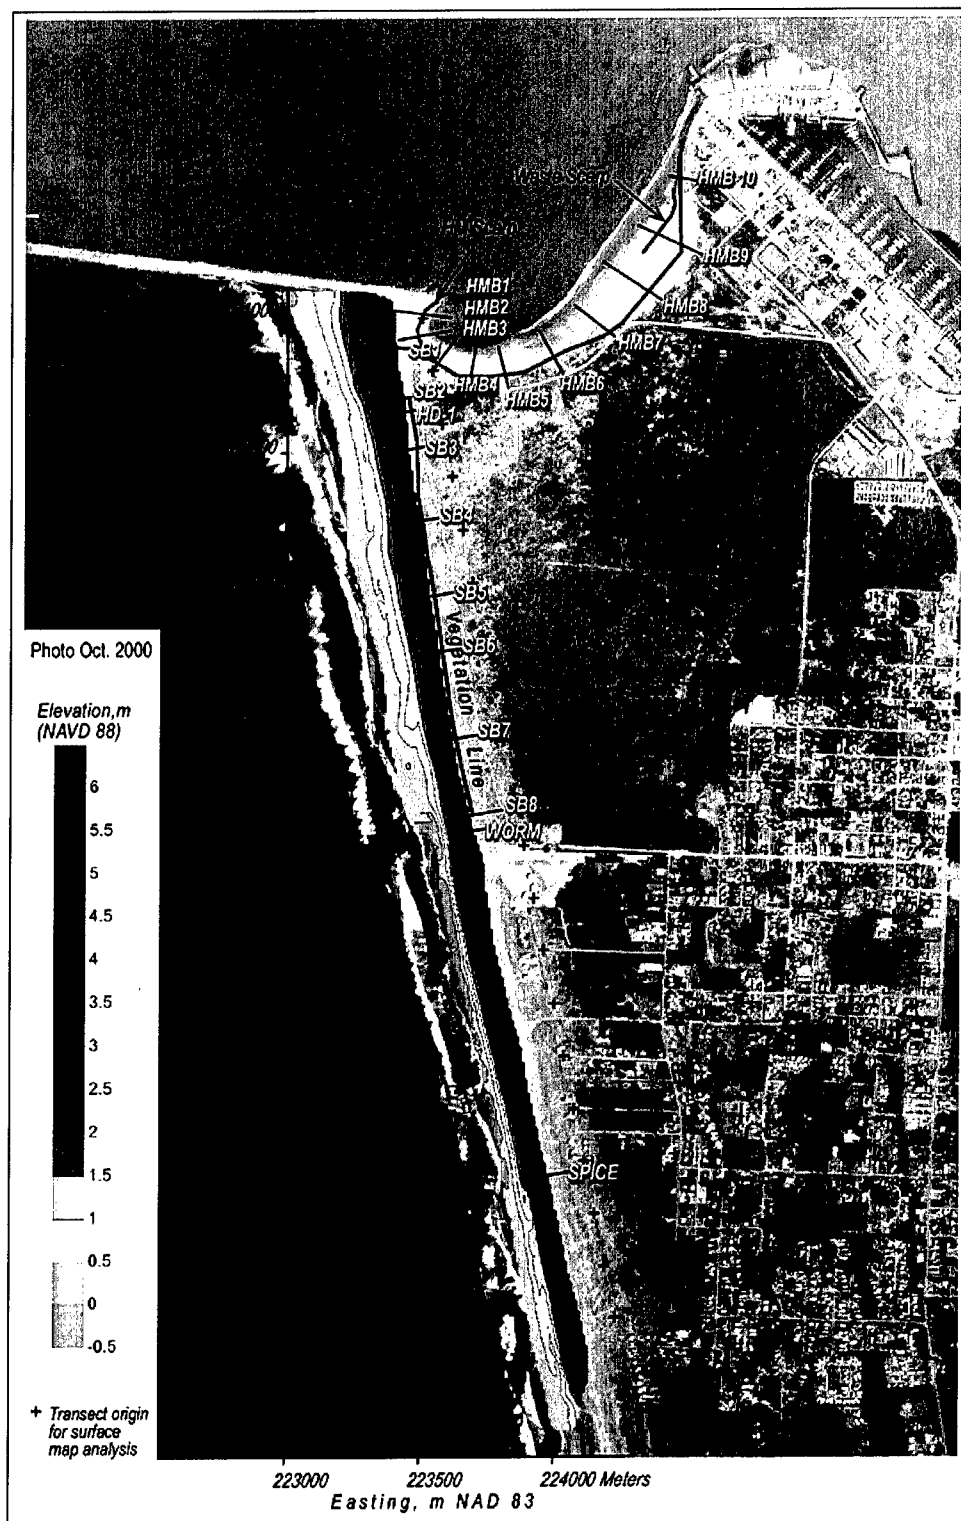
Figure 13. Surface map surveyed on 25 September 2000

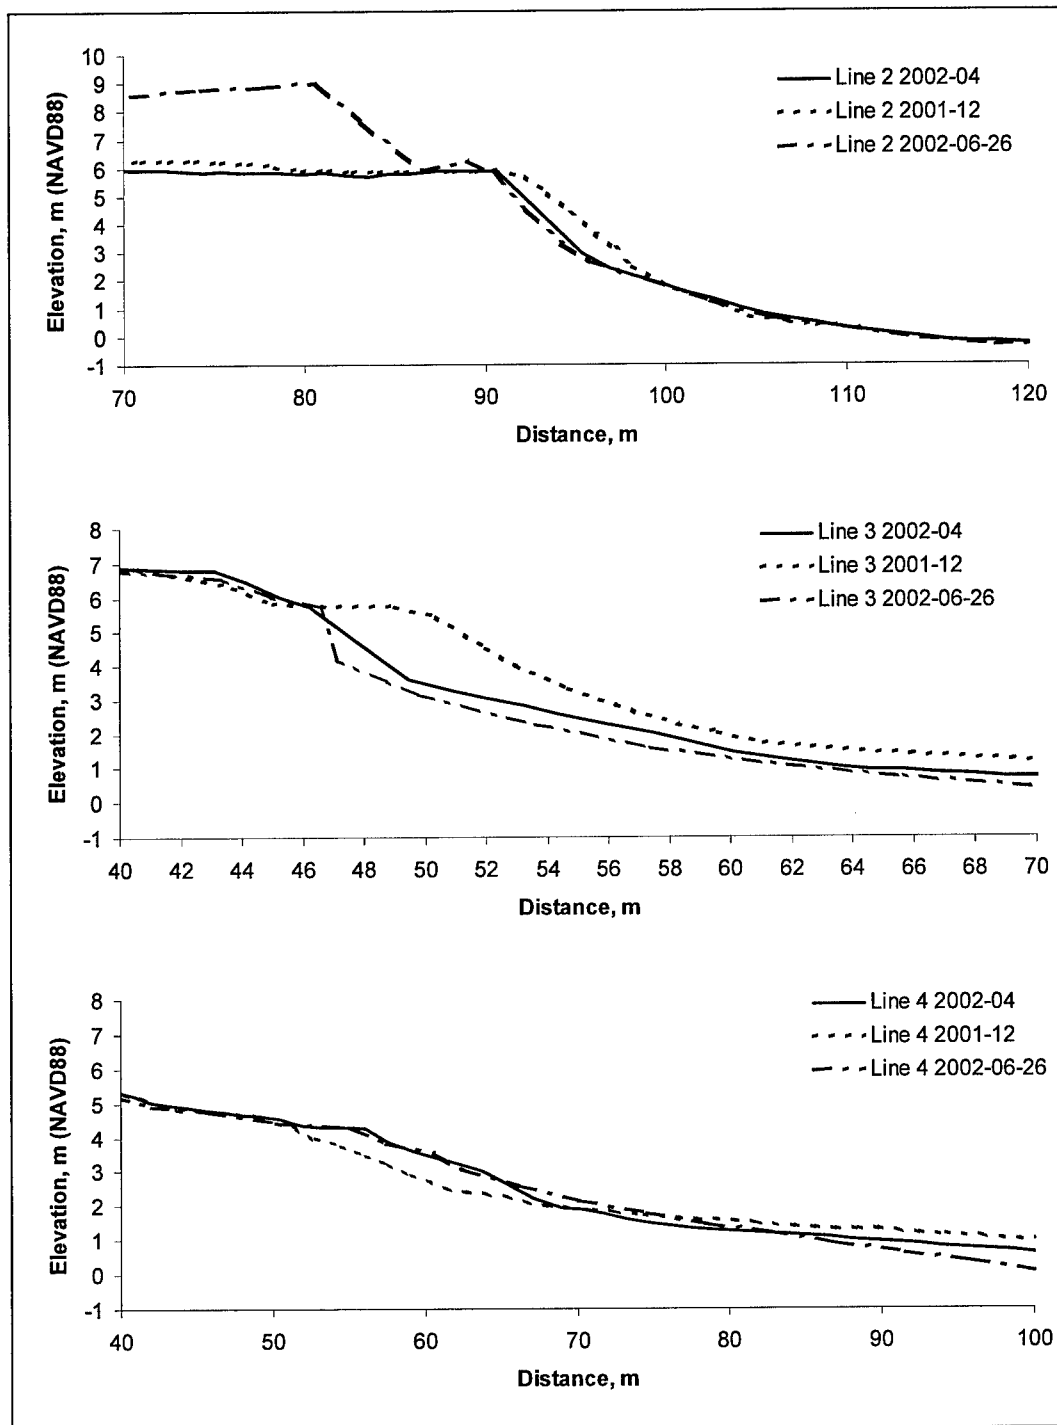
Figure 16. Profiles at Transects HMB2, HMB3 in gravel transition and Transect HMB4 east of transition

Profiles measured in December 2001, April 2002, and June 2002 at Transects HMB2, HMB3, and HMB4 (see Figure 8 for location) are shown in Figure 16. Transects HMB2 and HMB3 are in the gravel transition zone and Transect HMB4 is just beyond the eastward limit of the extended gravel zone. Comparison of the June 2002 survey of Transect HMB2 with the previous surveys illustrates the amount of material placed in the breach fill area during the emergency repair in May 2002. Transect HMB2 shows a net horizontal recession of approximately 1.5 m between 2- and 6-m elevation with most of the erosion occurring between December and April. Transect HMB3 shows a net recession of up to 4 m and lowering of the profile at all elevations below 6 m. Transect HMB4 shows a net accretion of the profile above the elevation of 2 m between December 2001 and April 2002.

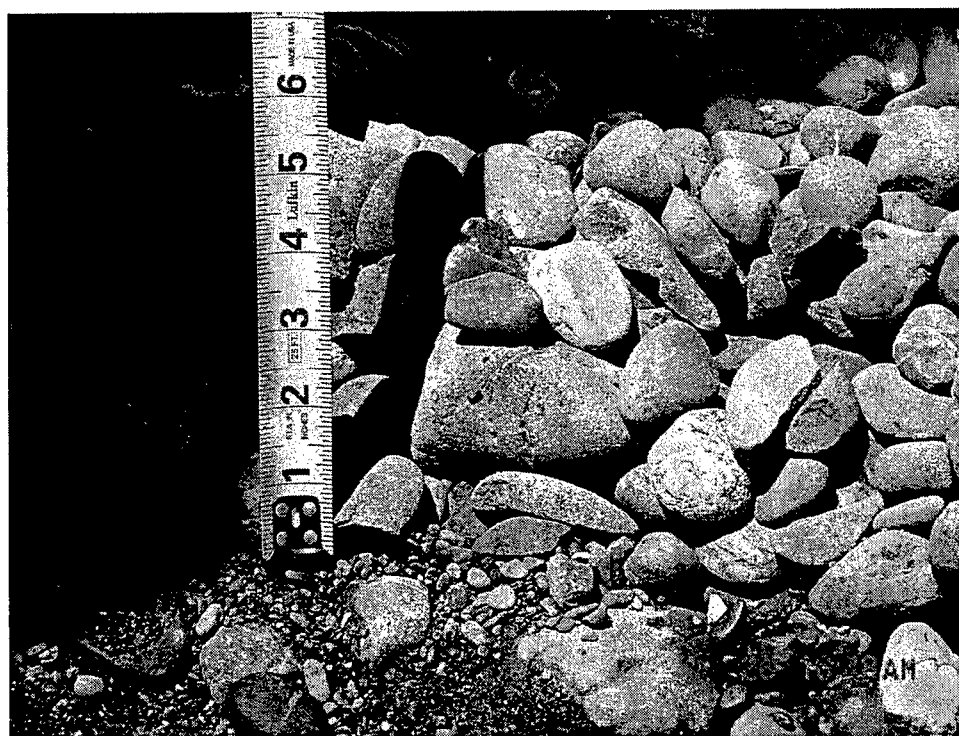
Figure 20. Transition gravel sorting on lower profile, 26 June 2002

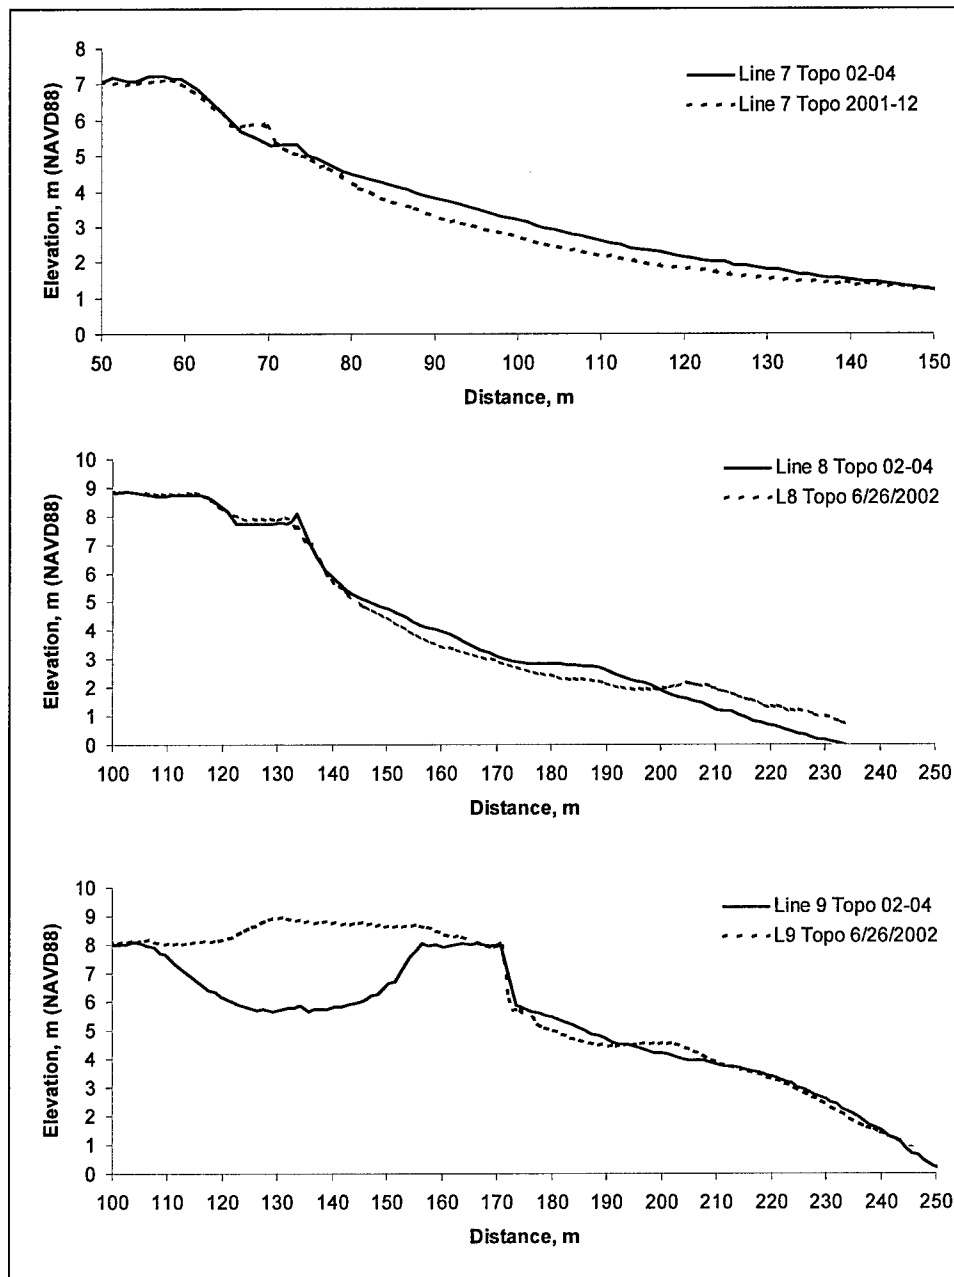
Figure 21. Beach profiles at Transects HMB7-9 above 0 m elevation

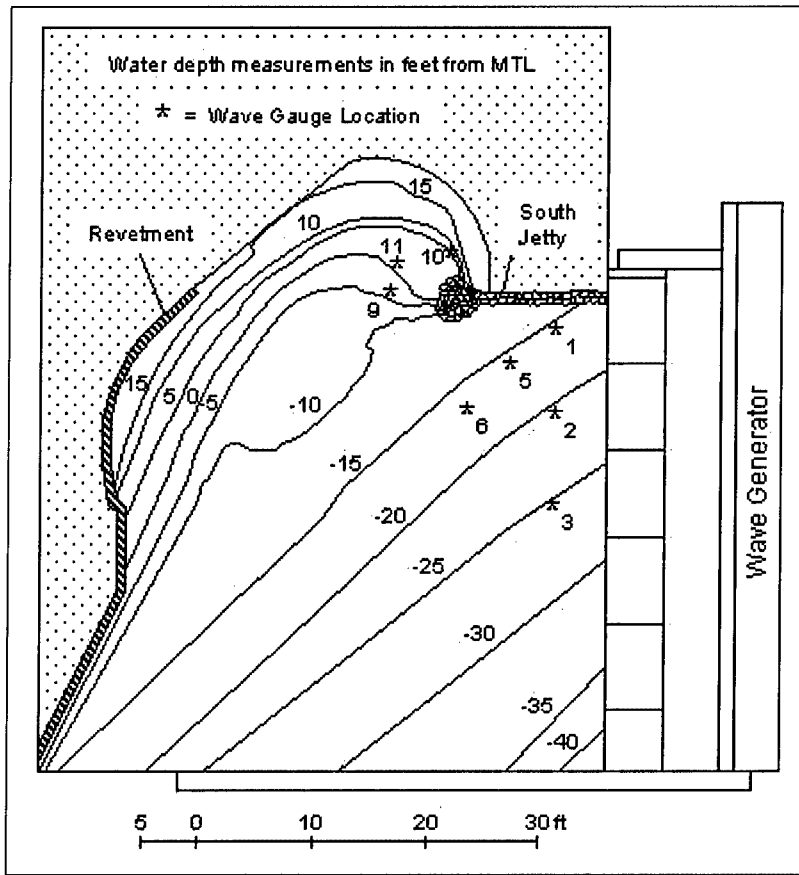
Figure 22. Physical model gauge locations model comparison
